# Total Methylmercury (ng/L) in Water

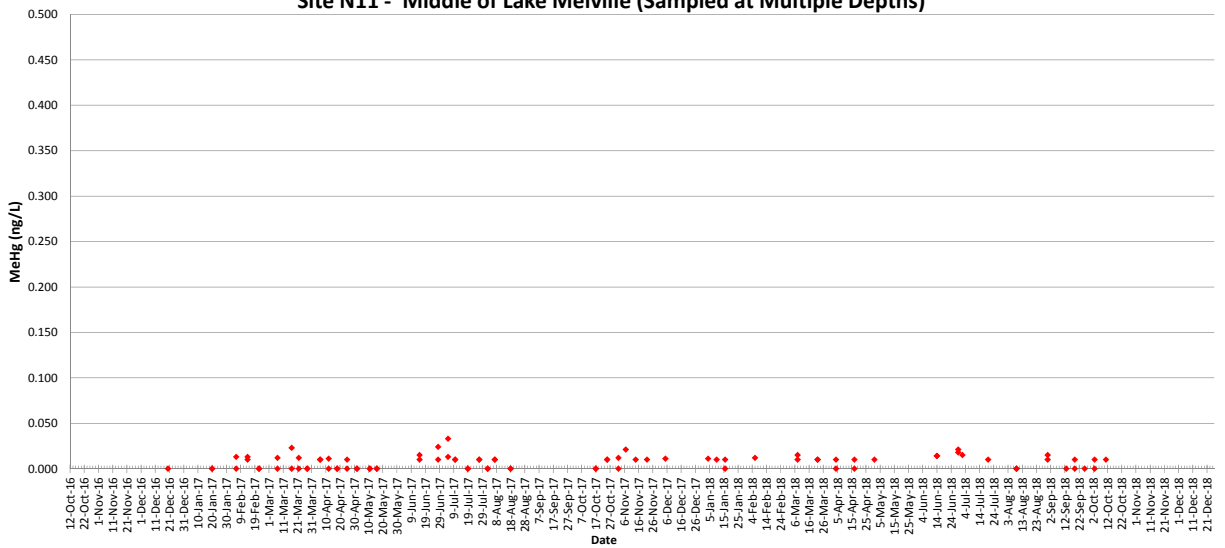
Site N11 - Middle of Lake Melville (Sampled at Multiple Depths)

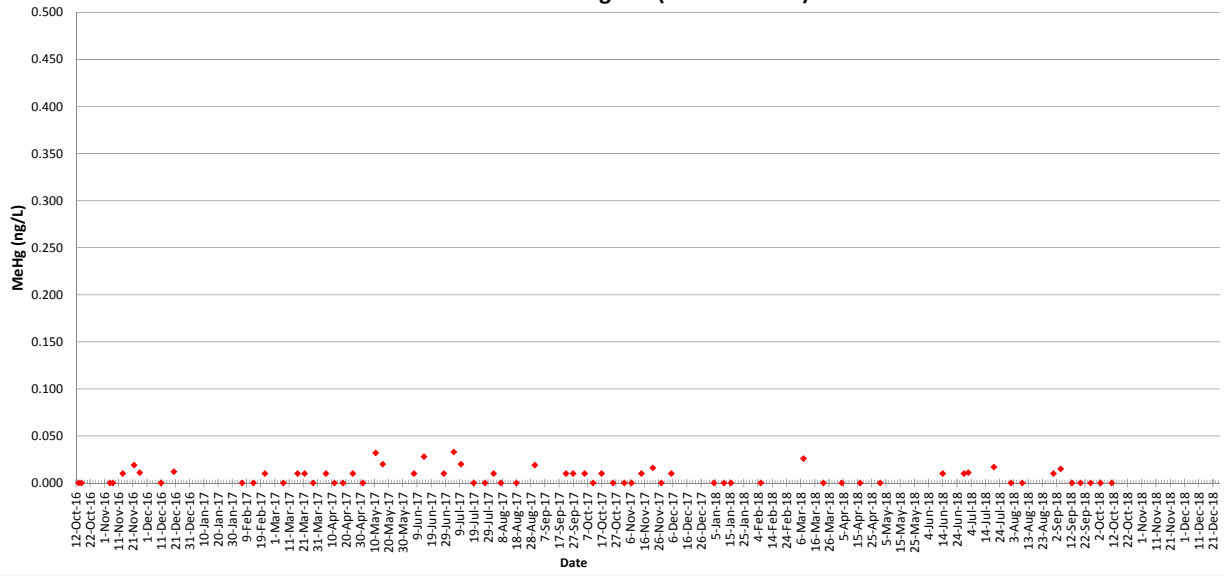
### Site N13 - Near Rigolet (Lake Outflow)
